Counties (MD/PA) Harford/York

A COMPARATIVE ASSESSMENT OF THE STATUS AND CONDITION OF THE MONUMENTS ON THE MASON AND DIXON LINE.

DATE OF OBSERVATION: 4 MAR 1988

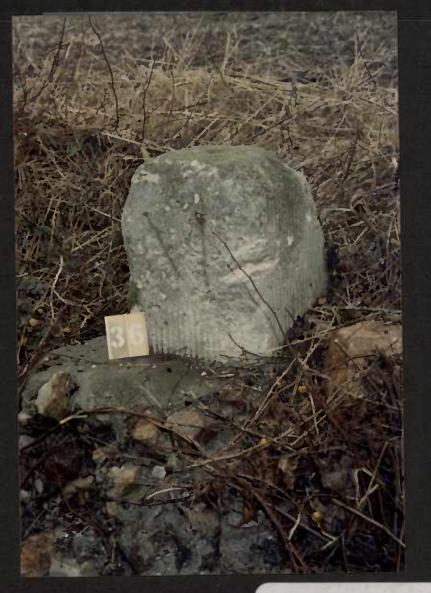
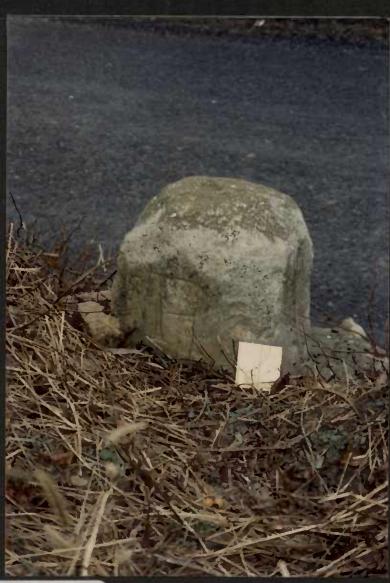
36 (38) 4 MAR 88

The stone is about 16" above the base on the M side and about 10" above ground on the P side. The base is exposed on the M side and the foundation is badly exposed on the South side next to the road. P and M are good.

This stone is extremely vulnerable to damage by farm machinery, vandals, and to traffic in general. Although the stone and foundation appear firm and solid, a large percentage of the foundation is exposed to weather and other sources of damage. M and Parelegible. The NGS witness post is missing. Traffic is on the increase.

Status: Endangered Condition: Fair

Foundation: Sound, Exposed South side.

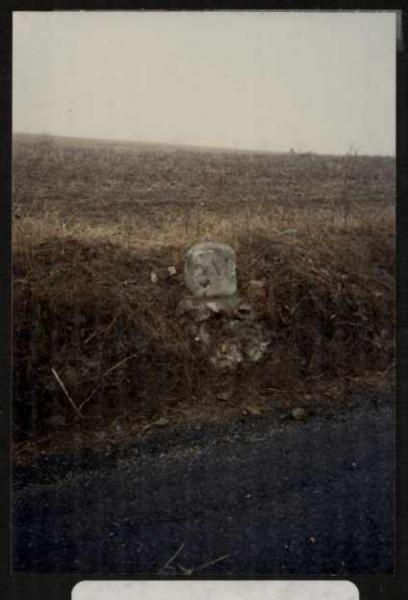
36 (38)
4 MAR 88
Large portion of foundation
exposed.
